# WISCONSIN COUNTY SURVEYORS ASSOCIATION NEWSLETTER

## **Successful Survey Despite Steep Challenges**

By Wade Pettit, Clark County Surveyor

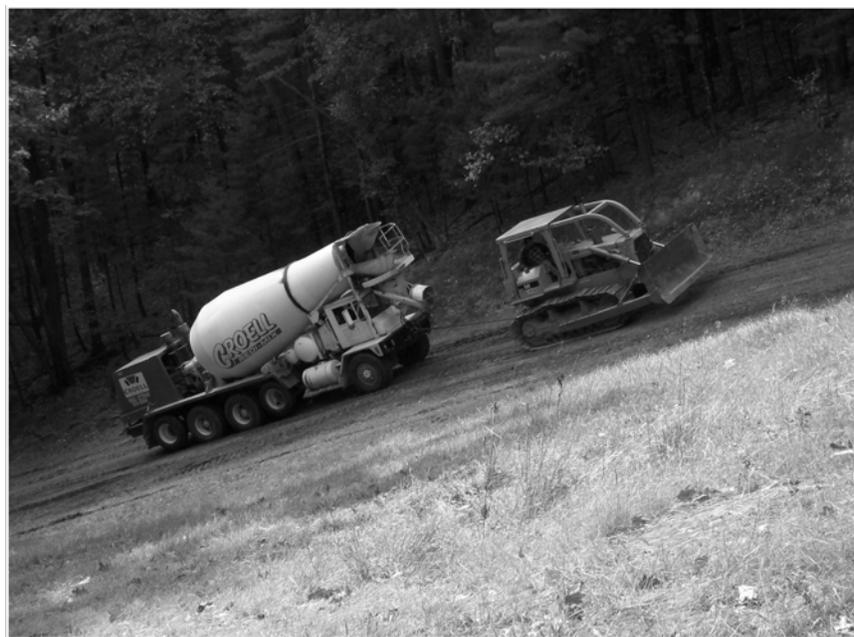
There were concerns about getting equipment and concrete to each of the tower locations. There was even discussion of using a helicopter. It was time to begin this project with a thought provoking plan of attack and several pieces of equipment. Bruce Mound has underlying sand and tight sandstone that was visible at the surface of several tower locations. Two medium sized tracked backhoes worked their way up the 340' vertical climb. One was equipped with a jackhammer and the other would use its bucket to remove the sand and rock.

Each hole was to be about 3 feet in diameter and 9 feet deep. The towers also had to be tipped so that they would be perpendicular to the chair cables at each location. This resulted in some towers being tipped as much as 29 degrees off vertical. Todd Lechliter was the engineer on site and knew the steps involved for construction of the tower bases. The process was much easier having his expertise on every aspect of what was being done. I was unsure how to determine the angle that each tower was to be tipped. Mr. Lechliter got out a clinometer and placed it on the pipe to set the angle. The first two towers were dug into sand, but soil and bedrock conditions changed drastically as we proceeded down the hill. The next six towers were located in solid sandstone. It took 5 hours to excavate each hole, and about the same to prepare each one for the pour.

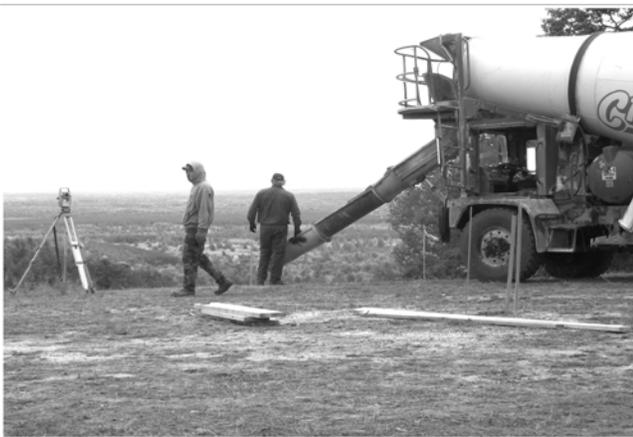
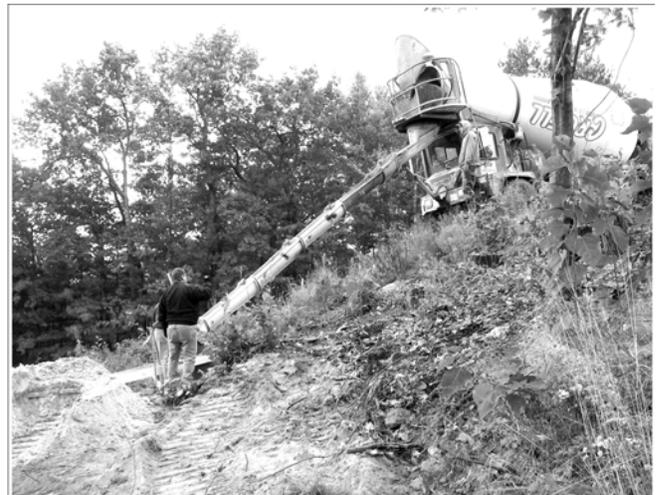
The next morning, the construction crew was ready to pour one of the bases. The concrete truck was assisted up the hill by a D6 dozer. The trucks could only haul half loads due to the weight and the fact that concrete would spill out the front chute when they began to go down to the lower towers. The top pour went well, and it was time to pour the next towers down. Two dozers at the top of the hill were hooked onto the concrete truck to take it down to the next pour. The driver was very nervous about going down the steep slope - this was an expert hill called "Death Valley." It is initially steep to start and then flattens to a small bench followed by a very steep slope. They had to go to the bench and then navigate out on the rock finger where many towers were located. It went smoothly and the next driver said that he didn't need a dozer and went down on his own, brakes locked up and sliding on occasions. If that truck got past the bench, it would be history, either continuing to the bottom or crashing into the trees..
